**Flood Control Project Maintenance
Levee Inspections**

Maintenance Issue Types Only, Levee Inspection Report By Mile - Spring 2016

Plumas County

Waterway	Bank	Unit Miles	Inspection Start/End	Inspector
Unit No. 01 North Fork Feather River	Left	1.89	04/27/2016 04/27/2016	Keith Millard

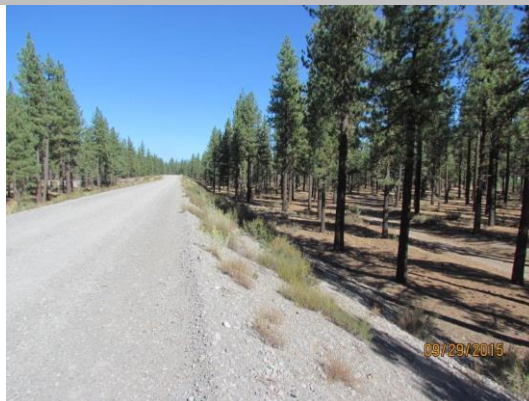
Photo 1 of 1 : SP_2016_NA0015_337_11_20160316_00008.jpg

LM Start	0.00	Rating **	M	Issue No.	11
LM End	1.89	Issue Type +	Ma	Location *	LS
Category	Earthen Levee			GPS Latitude/Longitude	
				Start	End
Item	Vegetation			40.273168 °	40.297283 °
				-121.244783 °	-121.257025 °
DWR ID	DWR_NA0015_01_f_2015_11				
Comment Code					
V2 : Remove the wild growth other than native grasses from the levee slopes.					
Inspector Comment					
Remove the small pine trees and other vegetation from the levee slope.

Remove the small pine trees and other vegetation from the levee slope.

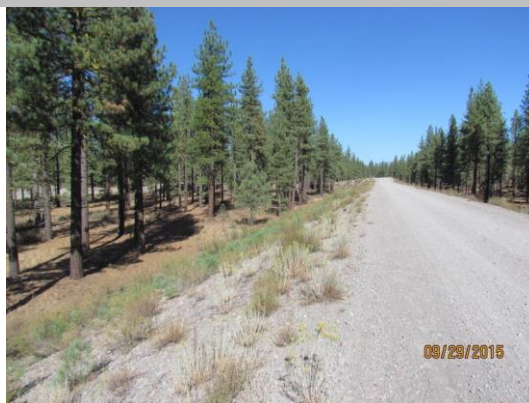
Photo 1 of 1 : SP_2016_NA0015_337_12_20160316_00009.jpg

LM Start	0.00	Rating **	M	Issue No.	12
LM End	1.89	Issue Type +	Ma	Location *	WS
Category	Earthen Levee			GPS Latitude/Longitude	
				Start	End
Item	Vegetation			40.273168 °	40.297283 °
				-121.244783 °	-121.257025 °
DWR ID	DWR_NA0015_01_f_2015_12				
Comment Code					
V2 : Remove the wild growth other than native grasses from the levee slopes.					
Inspector Comment					
Remove all small pine trees and other vegetation from the levee slope.

View of the small pine trees and other vegetation on the slope.

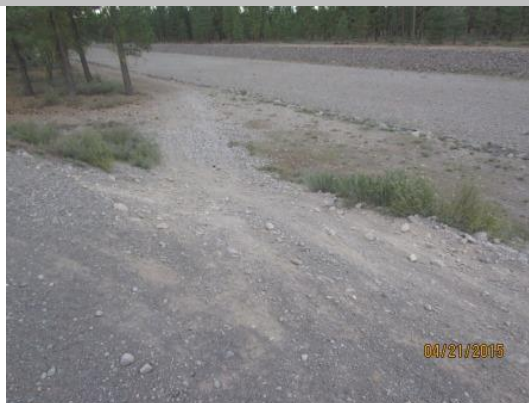
Photo 1 of 1 : SP_2016_NA0015_337_9_20160316_00007.jpg

LM Start	0.55	Rating **	M	Issue No.	9
LM End	0.55	Issue Type +	Ma	Location *	WS
Category	Earthen Levee			GPS Latitude/Longitude	
				Start	End
Item	Slope Stability			40.279790 °	121.249850 °
				40.279790 °	121.249850 °
DWR ID	DWR_NA0015_01_s_2012_9				
Comment Code					
S3 : Repair the levee slope damaged by vehicle traffic and prevent access where possible.					
Inspector Comment

View of the vehicle erosion along the waterside toe.

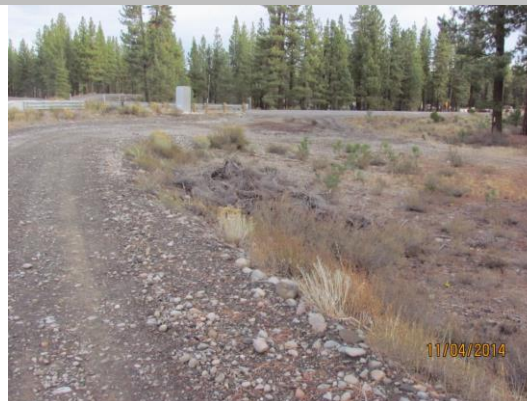
Photo 1 of 1 : SP_2016_NA0015_337_4_20160316_00001.jpg

LM Start	0.68	Rating **	M	Issue No.	4
LM End	0.68	Issue Type +	Ma	Location *	LS
Category	Earthen Levee			GPS Latitude/Longitude	
				Start	End
Item	Encroachments			40.281480 °	40.281480 °
				-121.250928 °	-121.250928 °
DWR ID	DWR_NA0015_01_s_2013_4				
Comment Code					
PR : Prunings					
Inspector Comment

View of the prunings along the landside slope.

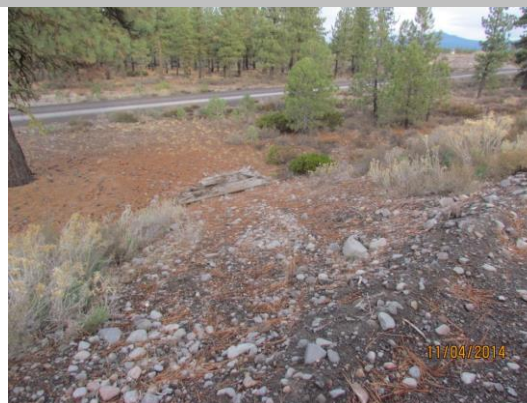
Photo 1 of 1 : SP_2016_NA0015_337_5_20160316_00002.jpg

LM Start	0.96	Rating **	A/W	Issue No.	5
LM End	0.96	Issue Type +	Ma	Location *	WS
Category	Earthen Levee			GPS Latitude/Longitude	
				Start	End
Item	Slope Stability			40.285363 °	40.285363 °
				-121.251973 °	-121.251973 °
DWR ID	DWR_NA0015_01_f_2013_5				
Comment Code					
S3 : Repair the levee slope damaged by vehicle traffic and prevent access where possible.					
Inspector Comment

View of the vehicle erosion along the waterside slope.

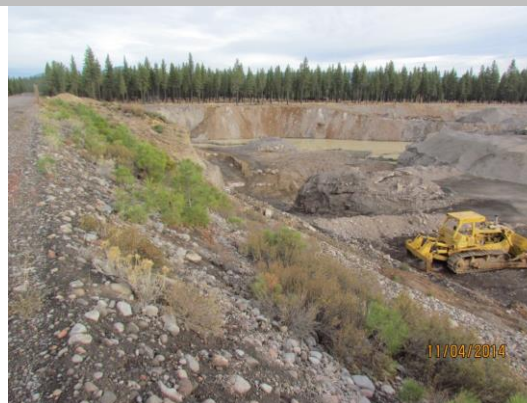
Photo 1 of 2 : SP_2016_NA0015_337_7_20160316_00004.jpg

LM Start	1.41	Rating **	U	Issue No.	7
LM End	1.50	Issue Type +	Ma	Location *	LS
Category	Earthen Levee			GPS Latitude/Longitude	
				Start	End
Item	Slope Stability			40.290758 °	40.291987 °
				-121.255402 °	-121.256072 °
DWR ID	DWR_NA0015_01_f_2014_7				
Comment Code					
S1 : Repair slope instability.					
Inspector Comment					
The landowner needs to replace the material that has been removed from the toe of the levee.

View of the area where the contractor has removed the material from toe of the levee.

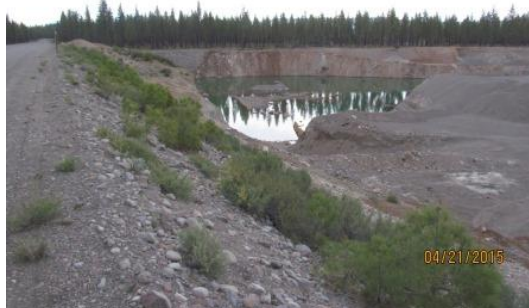
Photo 2 of 2 : SP_2016_NA0015_337_7_20160316_00005.jpg

LM Start	1.41	Rating **	U	Issue No.	7 (cont)	
LM End	1.50	Issue Type +	Ma	Location *	LS	
Category	Earthen Levee			GPS Latitude/Longitude		
				Start		End
Item	Slope Stability			40.290758 °		40.291987 °
				-121.255402 °		-121.256072 °
DWR ID	DWR_NA0015_01_f_2014_7					
Comment Code						
S1 : Repair slope instability.						
Inspector Comment						
The landowner needs to replace the material that has been removed from the toe of the levee.

View of the area where the contractor has removed the material from toe of the levee.

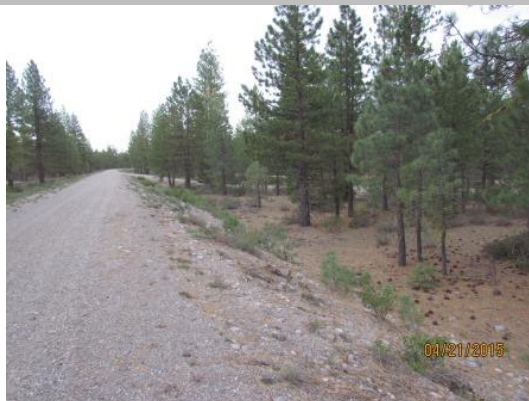
Photo 1 of 2 : SP_2016_NA0015_338_1_20160316_00001.jpg

LM Start	0.03	Rating **	M	Issue No.	1
LM End	1.36	Issue Type +	Ma	Location *	LS
Category	Earthen Levee			GPS Latitude/Longitude	
				Start	End
Item	Vegetation			40.286415 °	40.271743 °
				-121.259613 °	-121.246805 °
DWR ID	DWR_NA0015_02_f_2012_1				
Comment Code					
V2 : Remove the wild growth other than native grasses from the levee slopes.					
Inspector Comment					
Mow or remove the pine trees and other vegetation from the slope.

View of the small pine trees growing on the landside slope.

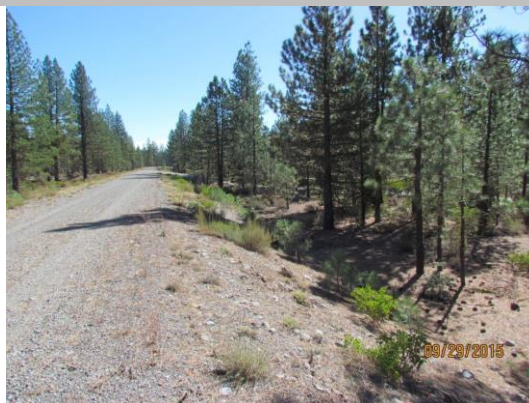
Photo 2 of 2 : SP_2016_NA0015_338_1_20160316_00002.jpg

View of the small pine trees and other vegetation growing on the slope.

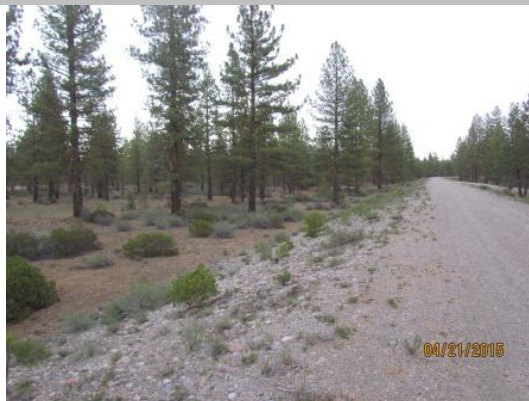
Photo 1 of 2 : SP_2016_NA0015_338_2_20160316_00003.jpg

LM Start	0.03	Rating **	M	Issue No.	2
LM End	1.36	Issue Type +	Ma	Location *	WS
Category	Earthen Levee			GPS Latitude/Longitude	
				Start	End
Item	Vegetation			40.286415 °	40.271743 °
				-121.259613 °	-121.246805 °
DWR ID	DWR_NA0015_02_f_2012_2				
Comment Code					
V2 : Remove the wild growth other than native grasses from the levee slopes.					
Inspector Comment					
Mow or remove the pine trees and other vegetation from the slope.

View of the small pine trees growing on the waterside slope.

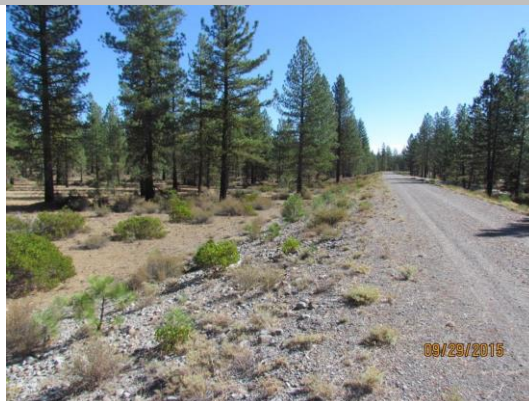
Photo 2 of 2 : SP_2016_NA0015_338_2_20160316_00004.jpg

LM Start	0.03	Rating **	M	Issue No.	2 (cont)	
LM End	1.36	Issue Type +	Ma	Location *	WS	
Category	Earthen Levee			GPS Latitude/Longitude		
				Start		End
Item	Vegetation			40.286415 °		40.271743 °
				-121.259613 °		-121.246805 °
DWR ID	DWR_NA0015_02_f_2012_2					
Comment Code						
V2 : Remove the wild growth other than native grasses from the levee slopes.						
Inspector Comment						
Mow or remove the pine trees and other vegetation from the slope.

View of the small pine trees and other vegetation growing on the slope.

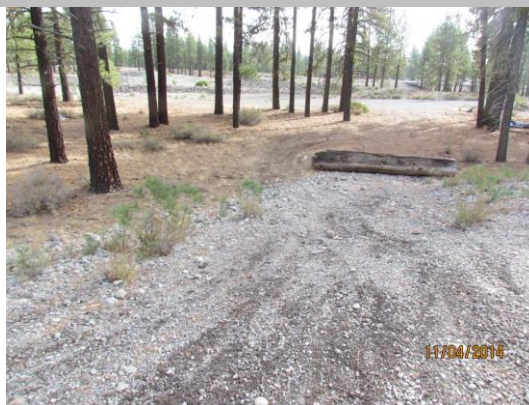
Photo 1 of 2 : SP_2016_NA0015_338_6_20160316_00007.jpg

LM Start	0.46	Rating **	M	Issue No.	6
LM End	0.46	Issue Type +	Ma	Location *	WS
Category	Earthen Levee			GPS Latitude/Longitude	
				Start	End
Item	Slope Stability			40.283059 °	40.283059 °
				-121.253989 °	-121.253989 °
DWR ID	DWR_NA0015_02_f_2013_6				
Comment Code					
S3 : Repair the levee slope damaged by vehicle traffic and prevent access where possible.					
Inspector Comment

View of the vehicle erosion on the landside slope.

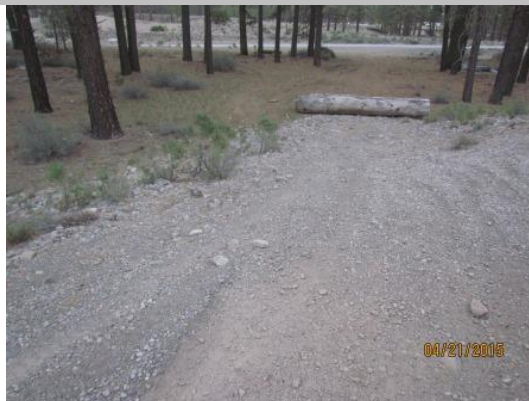
Photo 2 of 2 : SP_2016_NA0015_338_6_20160316_00008.jpg

View of the vehicle erosion on the waterside slope.

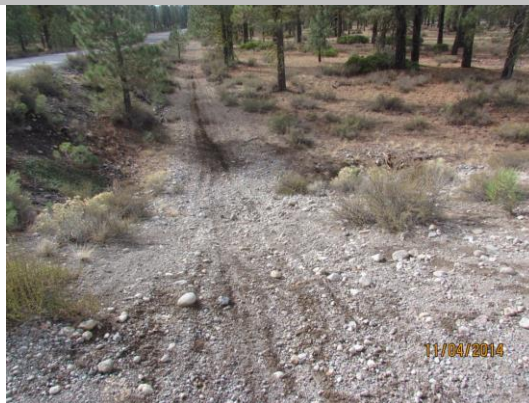
Photo 1 of 1 : SP_2016_NA0015_338_4_20160316_00005.jpg

LM Start	0.55	Rating **	M	Issue No.	4
LM End	0.55	Issue Type +	Ma	Location *	LS
Category	Earthen Levee			GPS Latitude/Longitude	
				Start	End
Item	Slope Stability			40.281950 °	121.253710 °
				40.281950 °	121.253710 °
DWR ID	DWR_NA0015_02_s _ 2012_4				
Comment Code					
S3 : Repair the levee slope damaged by vehicle traffic and prevent access where possible.					
Inspector Comment

View of the slope instability cause by vehicle along the landside slope.

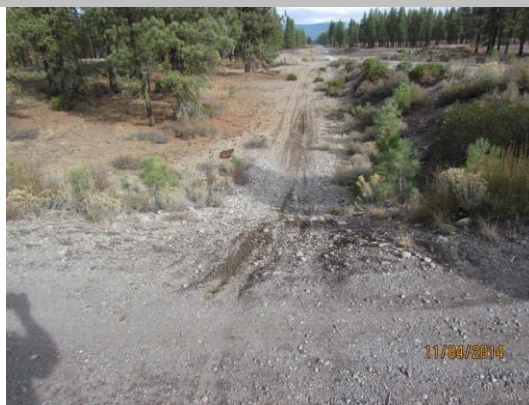
Photo 1 of 1 : SP_2016_NA0015_338_5_20160316_00006.jpg

LM Start	0.55	Rating **	M	Issue No.	5
LM End	0.55	Issue Type +	Ma	Location *	WS
Category	Earthen Levee			GPS Latitude/Longitude	
				Start	End
Item	Slope Stability			40.281950 °	121.253710 °
				40.281950 °	121.253710 °
DWR ID	DWR_NA0015_02_s _ 2012_5				
Comment Code					
S3 : Repair the levee slope damaged by vehicle traffic and prevent access where possible.					
Inspector Comment

View of the vehicle erosion on the waterside slope.
